Taipei, Taiwan
July 14, 1964

Revised:
Washington, D.C., USA
August 14, 1964

STRUCTURES INVESTIGATION REPORT
CONCERNING ACCIDENT TO CIVIL AIR TRANSPORT
C-46 DM, B-908, NEAR TAICHUNG, TAIWAN,
ON JUNE 20, 1964

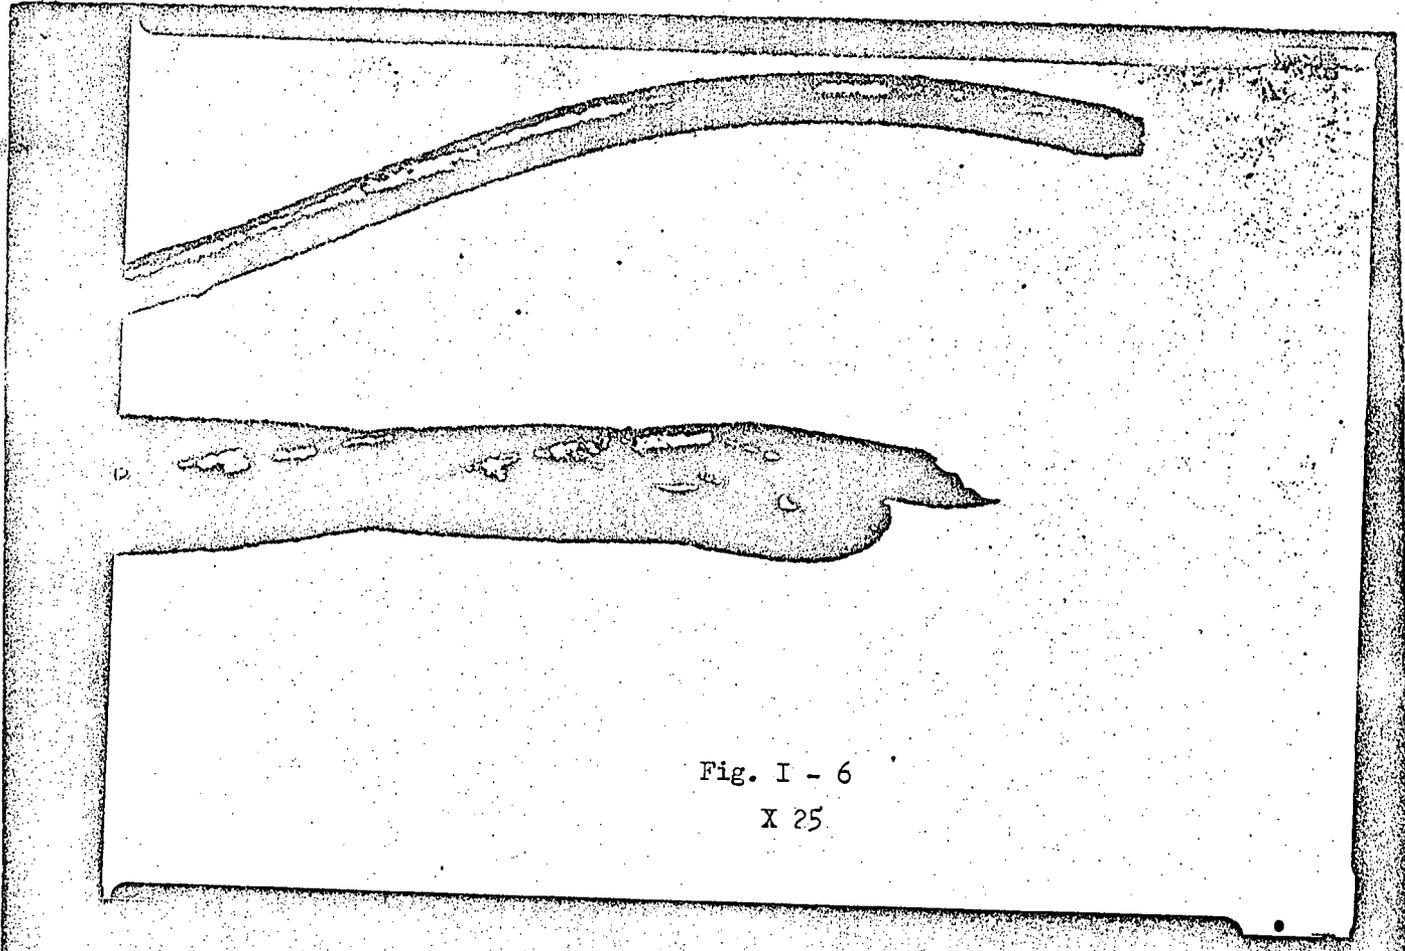
Fig. I - 6
X 25

The failed ends of the 49 wires in this 7 x 7 cable have three distinctly different appearances, as follows: 17 exhibit necking down, 18 are crimped, and 14 show wearlike damage characteristic of deformation due to one or a few interferences with a hard surface at very high pressure, rather than often repeated dragging over a surface at pressures consistent with those produced by a lightly loaded cable such as this one is in normal service. These three types of failed ends are shown in Figure I-6.

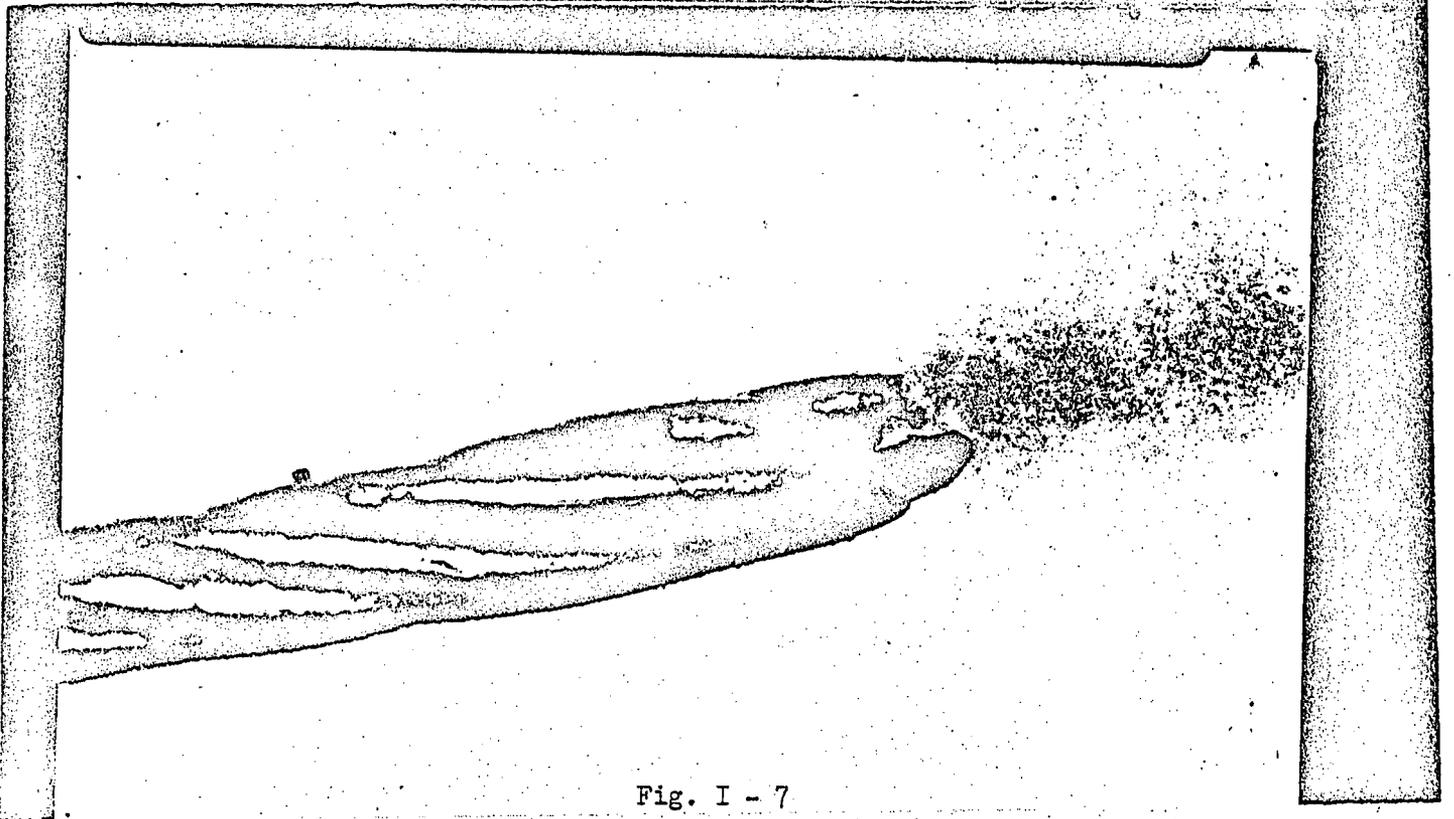
Fig. I - 7

The center strand of seven wires failed from tension overload, as shown in Figure I-7, with no indication of wear or other previous damage.

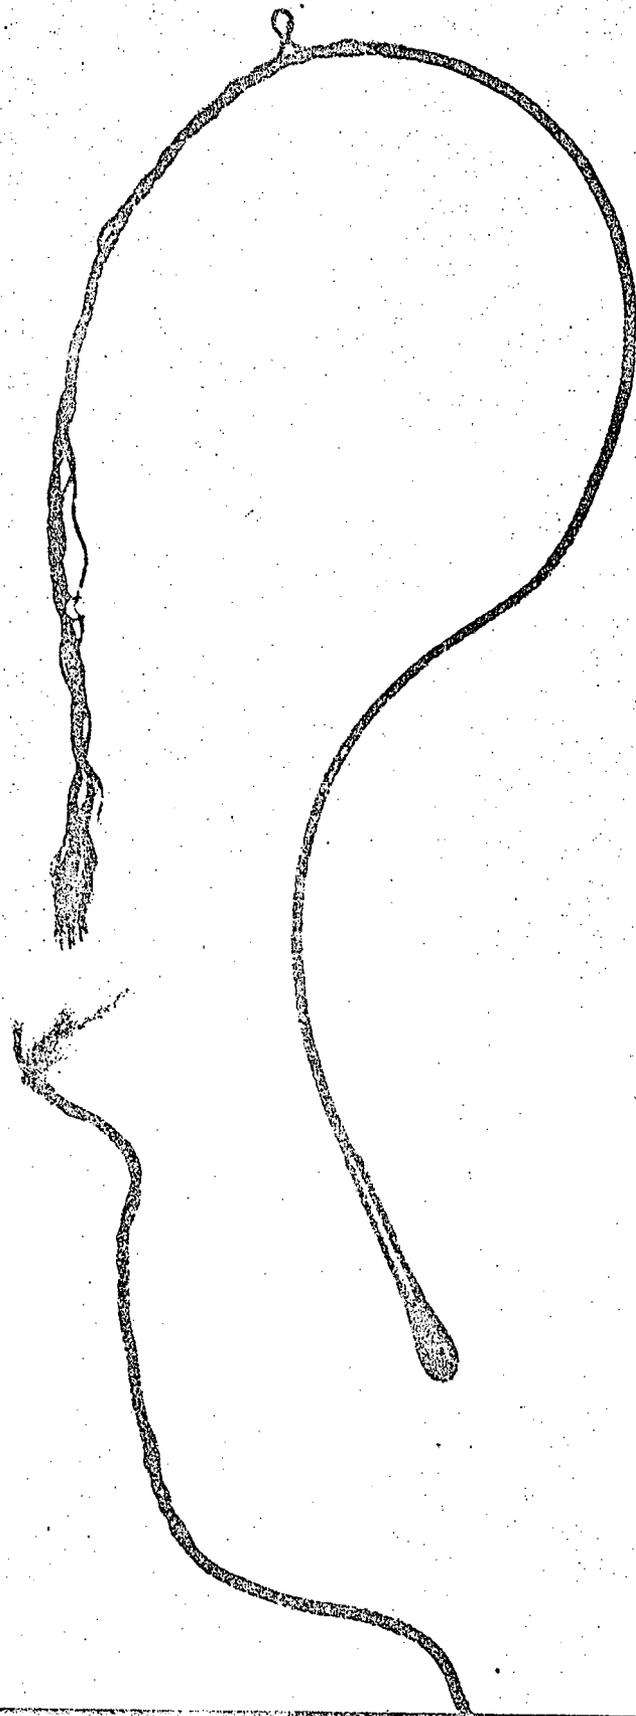
Fig. II-1
X 1/3

Figure II-1 shows the two pieces of right aileron down cable removed from the wreckage for laboratory examination, with the two frayed ends of the fracture area positioned adjacent to each other. This cable is 3/16" diameter 7 x 19 construction. The Engineering and Manufacturing Branch of the Federal Aviation Agency at Atlanta, Georgia, has advised that this is the proper diameter for the aileron down cable assembly, P/N 20-530-1212.

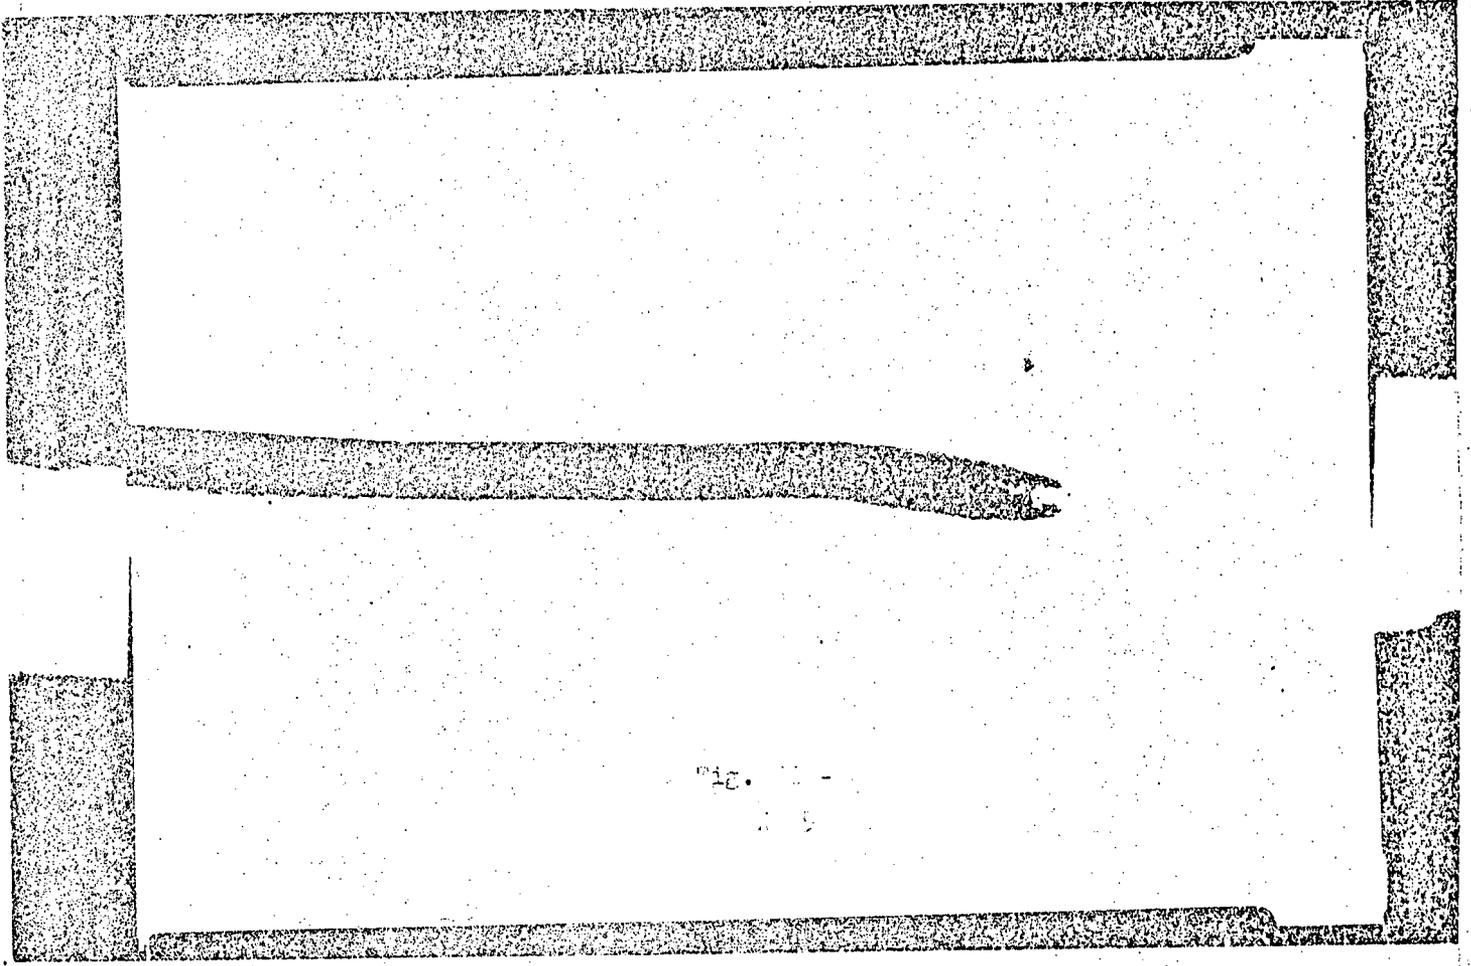
All wires of this cable failed due to tension overload. Figure II-2 shows a typical wire end with necking down adjacent to the fracture. No indication of significant wear or other unairworthy condition prior to disintegration of the airplane on impact with the ground was found in this examination.
